## UV- and plasma cleaning diffraction gratings

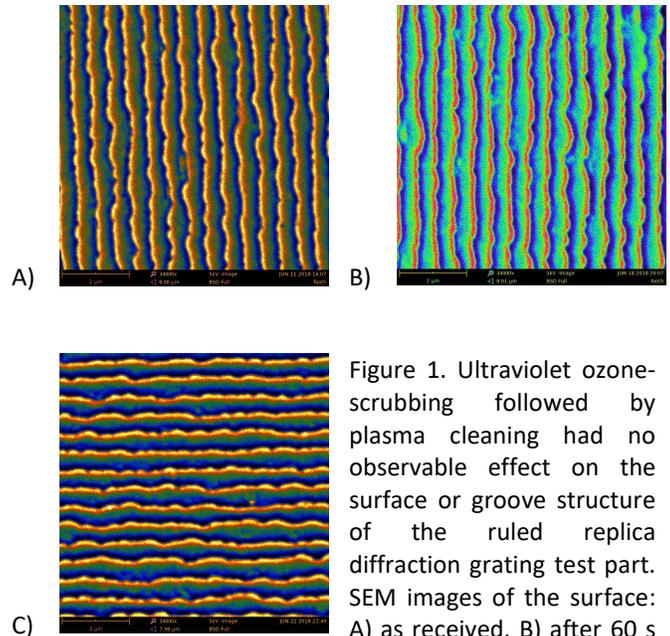
With UV ozone-scrub and plasma cleaning together or separately, measured diffraction efficiency improved. Approximately 10% improvement was measured, across the board, after the cleaning sequence. Scanning electron microscope (SEM) images from a Phenom Pure show no change to groove profile or surface of the diffraction grating.

Figure 1. Ultraviolet ozone-scrubbing followed by plasma cleaning had no observable effect on the surface or groove structure of the ruled replica diffraction grating test part. SEM images of the surface: A) as received, B) after 60 s ozone scrub, C) 60 s ozone scrub and plasma for three 60 s exposures. Arbitrary colors and groove direction

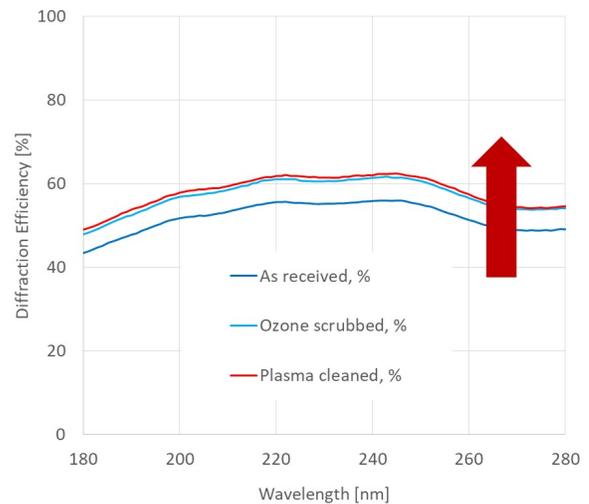
We measured efficiency of a UV ozone-scrubbed and plasma (nitrogen) cleaned replicated diffraction grating. For the test part, reflected diffraction efficiency measurements improve with each cleaning, overall 12% improvement on average. Scanning electron microscope (SEM) images of the optical surface do not indicate structural change or damage.

Figure 2. UV ozone-scrub and plasma cleaning improve measured diffraction efficiency
